**REPORT ON COMMON SWIFT IN TRALEE, CO. KERRY
PRODUCED IN 2016
FOR KERRY CO. CO. BIODIVERSITY OFFICER, CATHY FISHER**

By Lynda Huxley

PRELIMINARY SURVEY

JUNE 2016

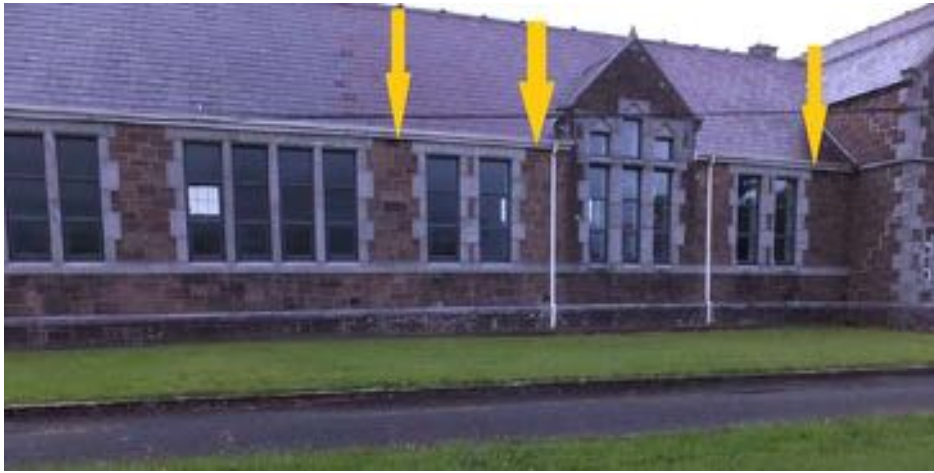
Site 1 : Scoil Eoin Balloonagh, Pembroke St. (R551)

On 24 and 25 June 2016, 6 nests sites were located at the front, side and rear of the building pictured below. This building is a protected structure as detailed above.

Front of building facing on to the R551. Orientation is South West

In addition, the school plans to reroof the stone building because the present roof is leaking. I recommend that any reroofing of this building should be carried out with the aim of protecting as many of the traditional nest sites as possible. **In order to protect all the nest sites, further survey visits should be carried in July of this year (2016) to identify the exact location of all or as many nest sites as possible**

Identifying the exact entrances of the nest sites will provide essential information which can be provided to the architect and builders who will be responsible for the reroofing. **The ideal time for reroofing which would cause least disturbance for the swifts would be between late August and early April.** **If this is not possible then it is vital that the swifts are not allowed to enter their nest sites when they arrive in late April. If they do enter their nest sites it would be illegal under the Wildlife Act for any work to commence during the breeding period. However, if the swifts were kept out of their nest sites for one year to allow the reroofing on the condition that the builders and architects undertook to retain the nest sites and keep the entrances open then because the swifts are totally faithful to their nest sites they would return the following year to breed (this has been proved to be successful in two projects in County Mayo).**

- a. Conduct a thorough survey in July 2016 to identify all the nest site entrances at the front and the rear of the building.
- b. Work with the school management, architects and builders to ensure the preservation of the existing nest sites when the building is reroofed.
- c. Work with the school management to have built-in nest boxes in the planned extension of the school.
- d. Install nest boxes as soon as possible on the tower near the school entrance.

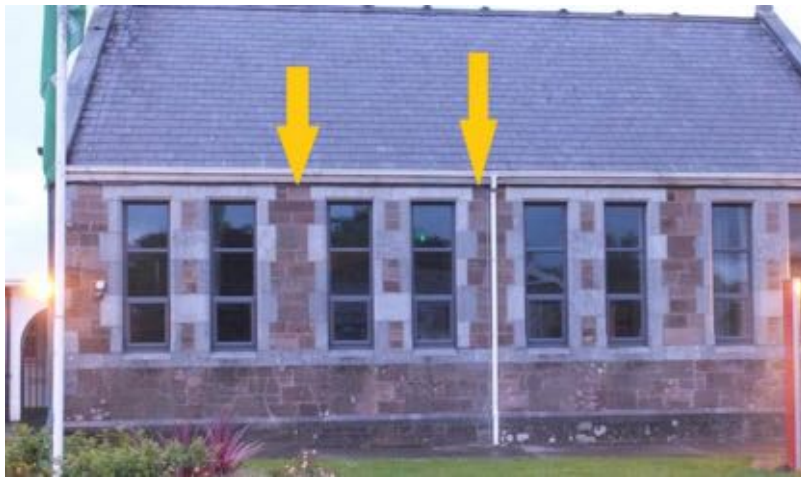
Side of the building near the school entrance gate. Orientation is North West.

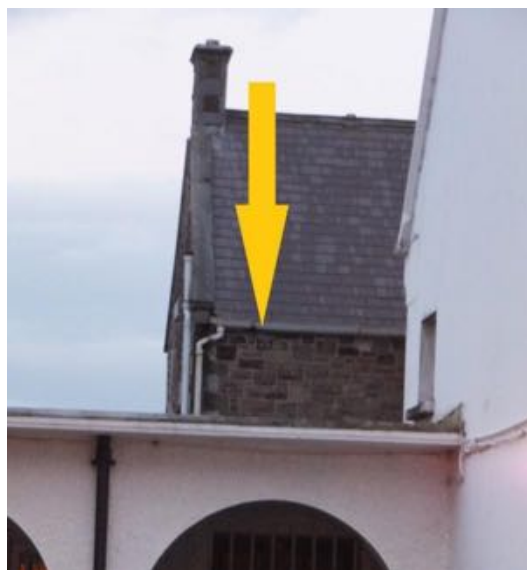
View of a section of the rear of building. Orientation is North West

It would be beneficial to gain access to the rear of the building on at least one morning (9-11am) and/or evening (10-10.45pm) to be able to find any nest sites at the rear of the building. The rear of the building is not usually accessible as the gates are locked so special access would need to be obtained.

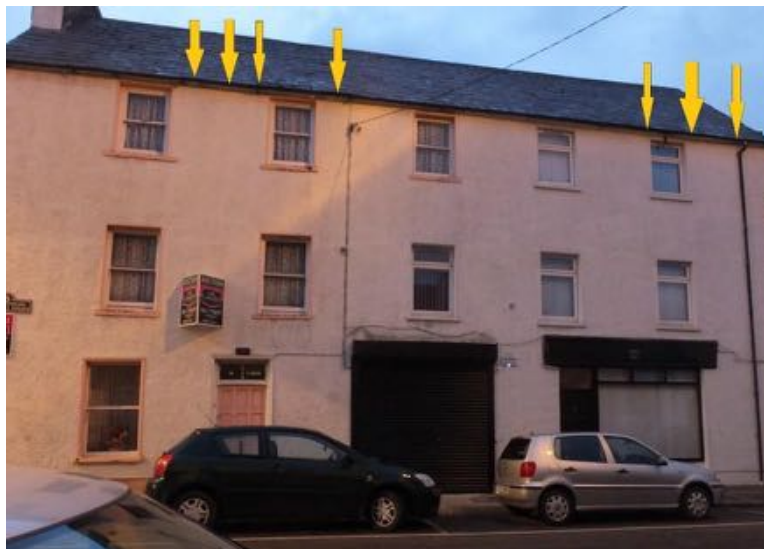
Site 2 : St Anthony's (Terraced Houses) Nos 8 & 9, Pembroke St. (R551)

This site is a very significant one given that it has at least 8 swift nest sites. It is located just across the road from Site 1: Scoil Eoin.

Both houses are private dwellings so the swift nest sites are vulnerable to being lost if the owners carry out any work to replace the roof or the original guttering without taking measures to protect the swift nest sites. Furthermore, No. 9 is for sale and the new owner may decide to carry out renovation work being unaware of the swift nest sites.

Front of the building on Pembroke Street. Orientation is South West

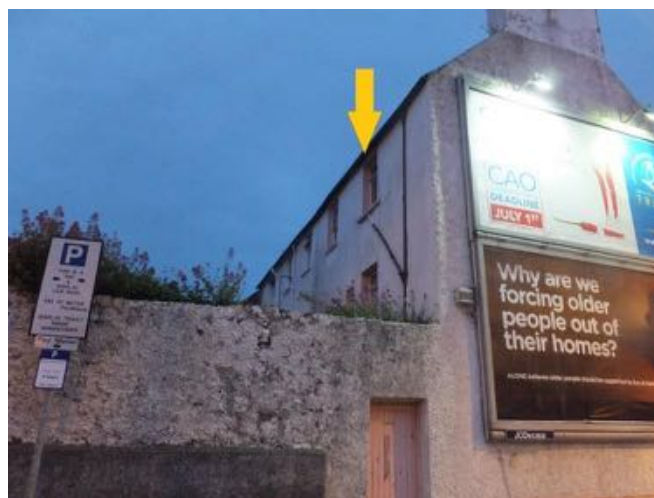
The rear of No. 8 has had new guttering so there is no access for swifts. However, the rear of No. 9 still has the original guttering and there is at least one nest site there.

Rear of No. 9 Pembroke Street. Orientation is North East

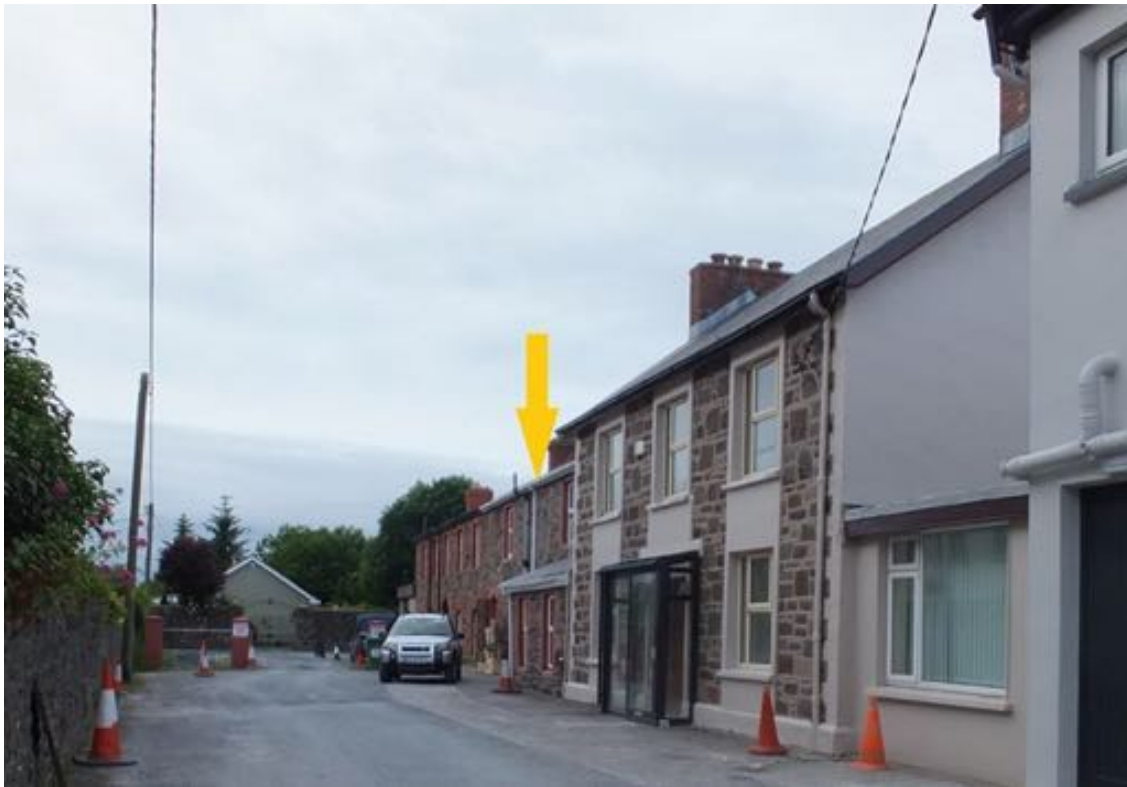
Site 3 : ASHE TERRACE, OFF ASHE STREET/NORTH CIRCULAR ROAD

Just one nest site entrance was located but there may be more because although the guttering has been replaced there are no soffits to restrict entrance to nest sites.

Rear of Eleanor's Florists. Orientation is South West

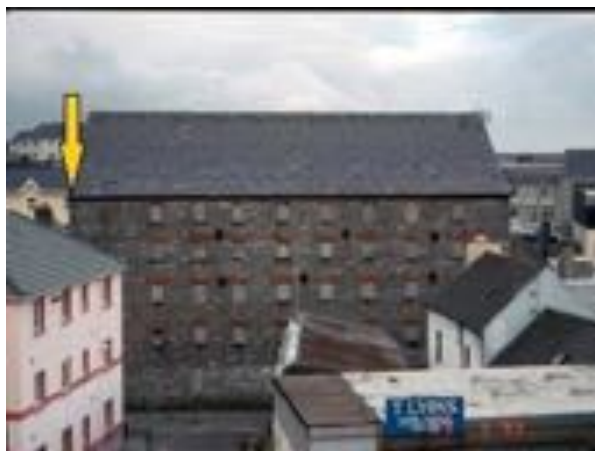
Site 4 : DISUSED MILL, MILK MARKET LANE/BROGUE MAKER'S LANE

One swift nest site was located as indicated below, however, I suspect there are several more. I would recommend a further survey of this site.

Side of the Disused Mill on Brogue Maker's Lane. Orientation is North West

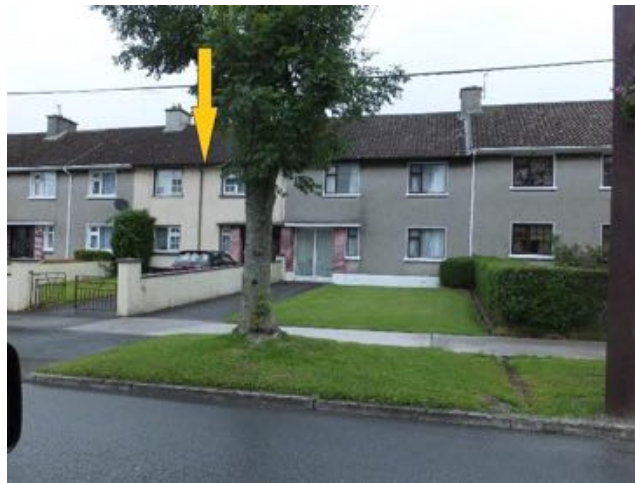
Longitude 52.278053 Latitude -9.703889 Orientation is South West

St Brendan's Park housing estate was probably the hub of the swift population in years gone by. However, the vast majority of the houses have now had the original guttering replaced with new guttering containing a plastic soffit.

There are still some houses with the original guttering and on these houses the rafters provide an overhang at the front of the house. This has provided entrance to nest sites for swifts.

Two nest site entrances were found in two properties with original guttering/rafters. There are undoubtedly more nest sites and I would recommend a full survey is carried out on this housing estate.

- a. Conduct a full survey of the estate in July 2016 to assess how many houses still have the original guttering system with rafters exposed. In addition, try to identify how many of these still have nesting swifts.
- b. If there is a housing/tenants association work with them to find out if any house owners are interested in installing nest boxes.
- c. Look into possibility of installing a swift tower in open grass area (see aerial image below) as per the one installed by Roscommon Tidy Towns (see pic below). And/or installing nest boxes on pharmacy building at the entrance to the estate. By installing nest boxes this will help the population recover by providing nest sites for young birds that want to start breeding.

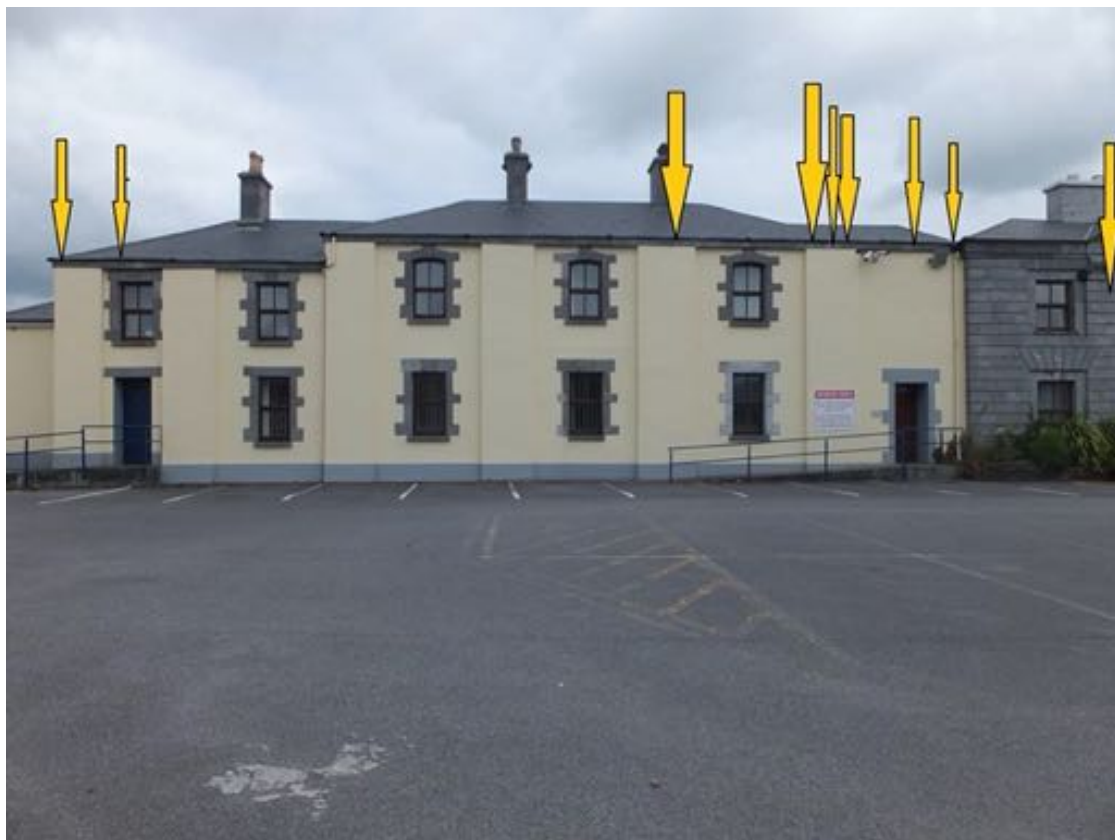
Site 6 : KELLIHER'S OFFICE, GARRYRUTH, CLOONBEG TOWNLAND

This building was an army barracks. The nest site entrances are in gaps in the stone work just below the guttering.

It is quite feasible that there are more nest sites in the this building at the front but unlikely that there are any at the rear because a new warehouse has been built which joins on to the old building.

Front of the building near main entrance to Kelliher's. Orientation is West

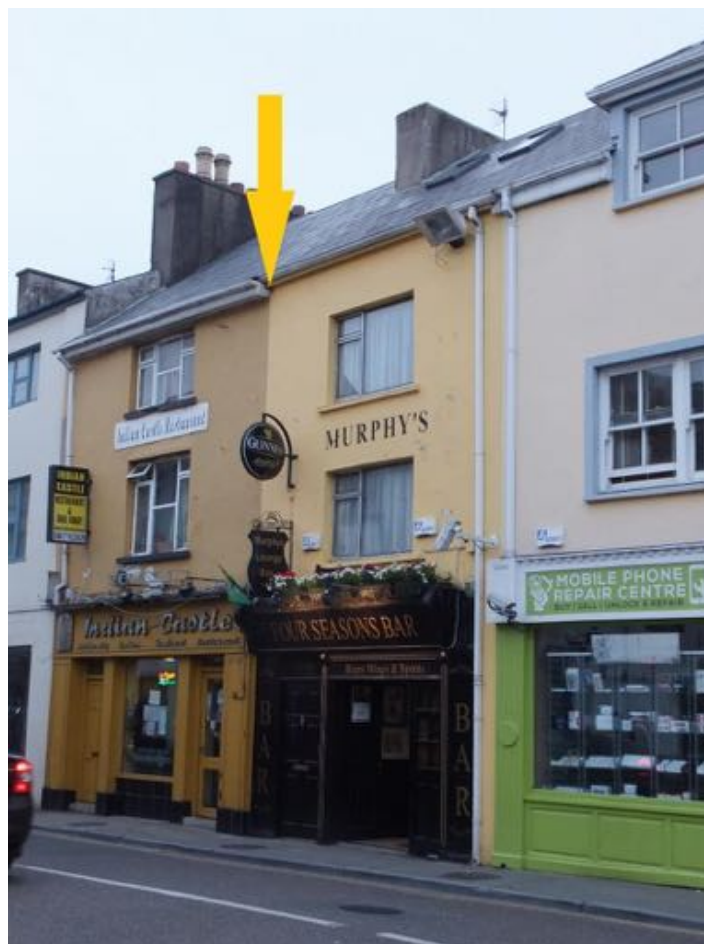
Site 7 : MURPHY'S 'FOUR SEASONS' BAR, UPPER CASTLE STREET

A single nest site located in a gap where the guttering from the Indian Castle restaurant meets the guttering of Murphy's Bar.

Front of the building on Upper Castle Street. Orientation is South

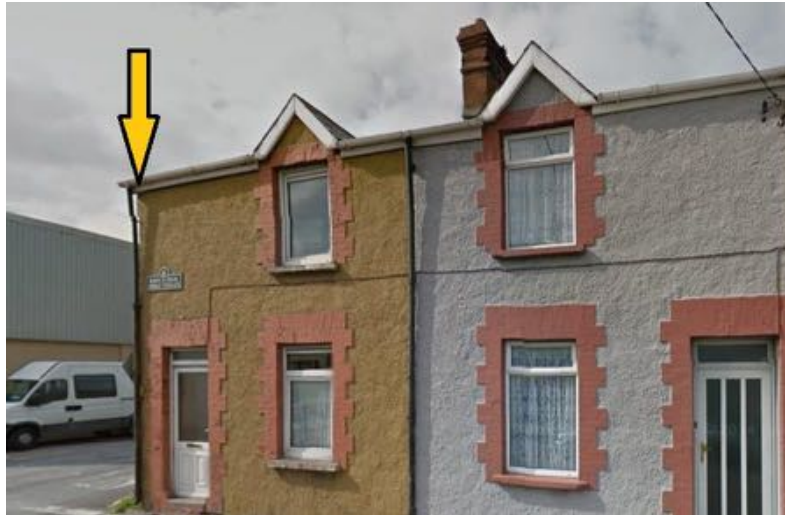
No. 1 Urban Terrace. Orientation is South East

Urban Terrace fronts on to Upper Rock Street. It is quite possible that there are more than two nest sites in the terrace so it would warrant further investigation.
